DEPARTMENT OF TRANSPORTATION**DIVISION OF ENGINEERING SERVICES**

Quality Assurance and Source Inspection

Contract #: 04-0120F4Cty: SF/ALA Rte: 80 PM: 13.2/13.9File #: 1.28**WELDING INSPECTION REPORT****Resident Engineer:**Siegenthaler, Peter**Address:** 333 Burma Road**City:** Oakland, CA 94607**Report No:** WIR-026214**Date Inspected:** 30-Aug-2011**Project Name:** SAS Superstructure**OSM Arrival Time:** 700**Prime Contractor:** American Bridge/Fluor Enterprises, a JV**OSM Departure Time:** 1730**Contractor:** American Bridge/Fluor Enterprises, a JV**Location:** Job Site

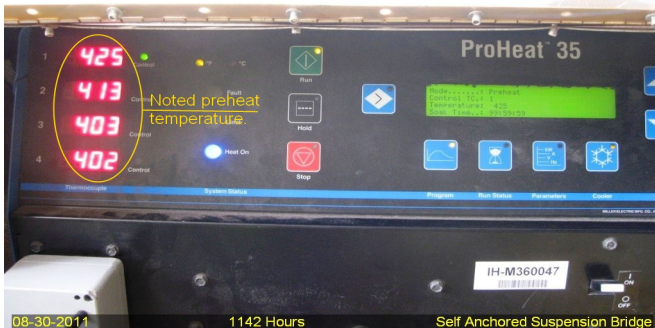
At Tower Base Elevation Electro Slag Welding (ESW) T-joint E-041 location 'R', QA randomly ABF welder Richard Garcia continuing to perform 3G SMAW first time welding repair (R1) on the visually (VT) detected defect on the surface of the vertical weld of the ESW. The welder was observed welding in the 3G (vertical) position utilizing Shielded Metal Arc Welding (SMAW) with 1/8" diameter E7018H4R electrode implementing welding procedure ABF-WPS-D15-1000-Repair Rev. 2. The boat shape repair excavation located at Y=1435mm to Y=1710mm was excavated to dimensions of 275mm long x 60mm wide x 40mm deep. The excavation was previously tested using Magnetic Particle Testing (MT) by ABF QC Steve Mc Connell and this QA with linear indications still exist after 40mm deep excavation. The repair excavation and the adjacent base metal was preheated and maintained to more than 204°C (400°F) using Miller Proheat Induction Heating System with the heater blankets placed at the other side of the repair. During the shift, ABF QC John Pagliero was noted monitoring the welder. Measured welding parameter during welding was 140 amperes on a 1/8" diameter E7018H4R electrode. At the end of the shift, repair welding was still continuing and should remain tomorrow. The welder has programmed the Miller Proheat 35 Induction Heating System to hold the preheat of 400°F for three hours and cool down at 150°F per hour as recommended by ABF.

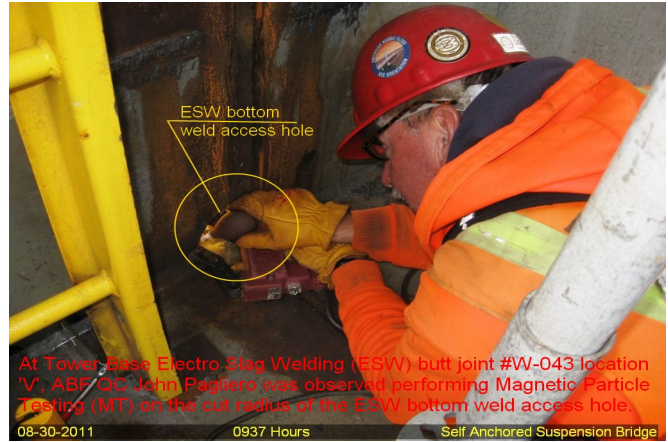
At ESW locations 'P', 'Q', 'V' and 'T', ABF QC John Pagliero was observed performing Magnetic Particle Testing (MT) on the bottom radius weld access holes. These holes were cut from the bottom of the ESW where the sump block was put in place to serve as starting point for the ESW. The MT result on three (3) weld access holes 'P', 'Q', 'V' were positive except on one hole 'T' where linear indication was noted and gouged surface left not ground. This QA performed MT verification on the radius of the mentioned bottom weld access holes and noted same result.
